**U.S. Naval Supply Research & Development Facility
Bayonne, New Jersey**

21 February 1952

INTERIM REPORT ON THE INSTALLATION
OF
CARBON MONOXIDE ELIMINATOR MUFFLERS

ENGINEERING REPORT NO. 5.2120
Project Group No. NT-003-020(b)

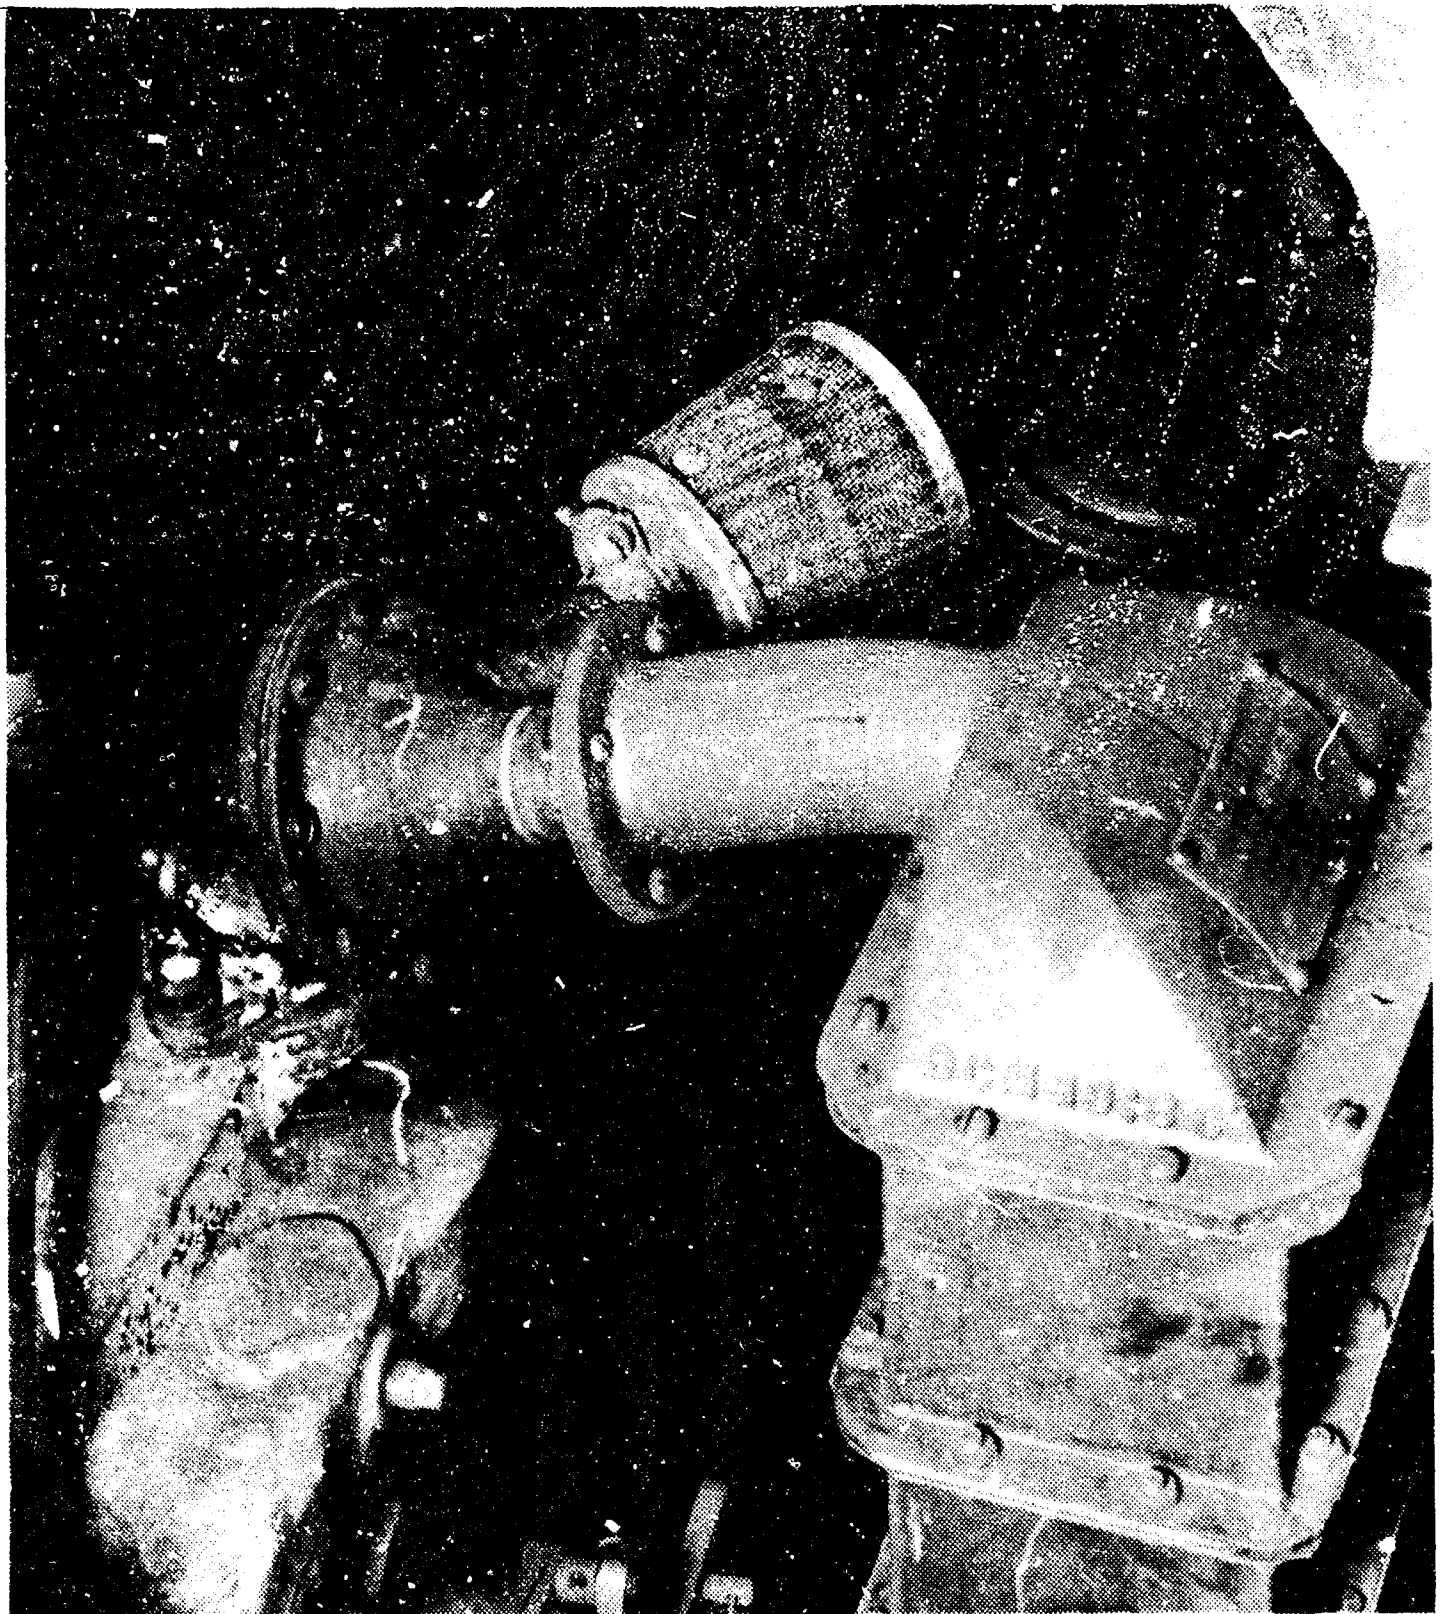
FIG. 2 ILLUSTRATION OF REPAIRS NECESSITATED BY CRACKING OF FLANGE DUE TO WEIGHT OF MUFFLER. (USNSRDF NEG. NO. RDF-596-2)

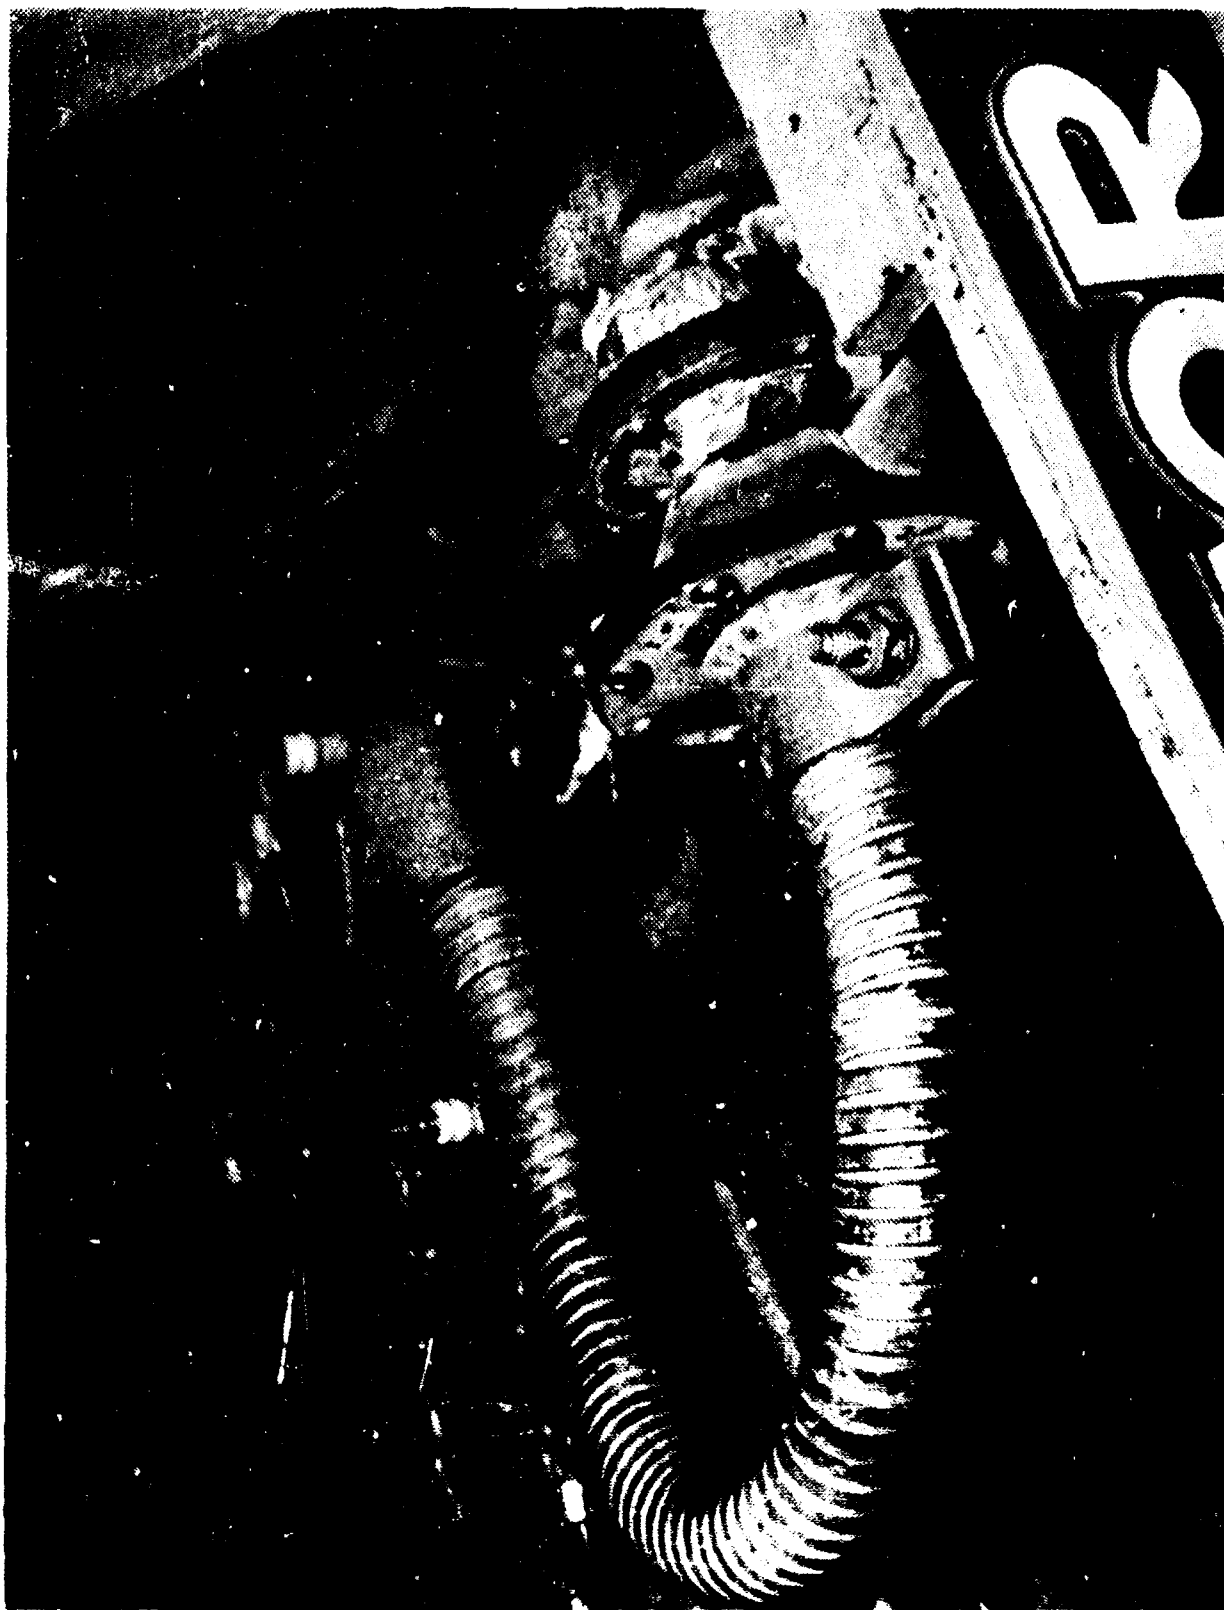
FIG. 5 CLOSE-UP OF MANIFOLD CONNECTION SHOWING USE OF FLEXIBLE HOSE
IN AN ATTEMPT TO ELIMINATE BREAKAGE OF THE VENTURI.
(USNSRDF NEG. NO. RDF-26-2)

These failures led to a search for a new method of fastening the muffler to the engine and for supporting the muffler more adequately. A method of connecting the manifold to the muffler by means of a flexible coupling was attempted. See Figure 5. In this method the muffler was fastened rigidly to the frame and the flexible tubing was designed to take out the vibration between the engine and the frame. This method of coupling is presently under test.

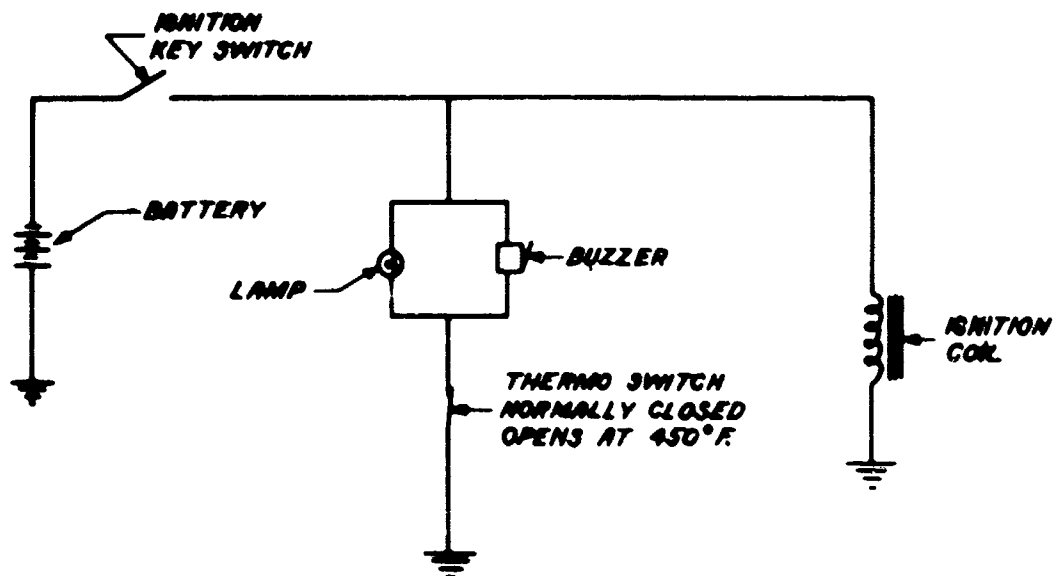
An audio-visual alarm has been mounted on these five machines incorporating a new circuit design. See Figure 18. The circuit now operates on a thermal switch that is closed until the muffler comes up to temperature. See Figure 19. The closed circuit switch energizes a buzzer and danger lamp that remain on until the thermal switch opens

FIG. 19 - REDESIGNED ALARM SYSTEM NOW IN USE.

and the circuit is broken. This alarm system has been found to operate satisfactorily and will indicate proper muffler operation as long as the engine is not operating continuously under heavy load. Under this condition, the temperature of the exhaust gases may be high enough to keep the alarm off, although the muffler is not operating properly. The Underwriters Laboratory, Inc. confirms this in a report^{6/} on the catalyst muffler.
